Ram Truck 1500K 4WD

Differential Housing Repair / RHS, 2012-up
INTERMEDIATE SHAFT - REPAIR KIT
CH-3511RK

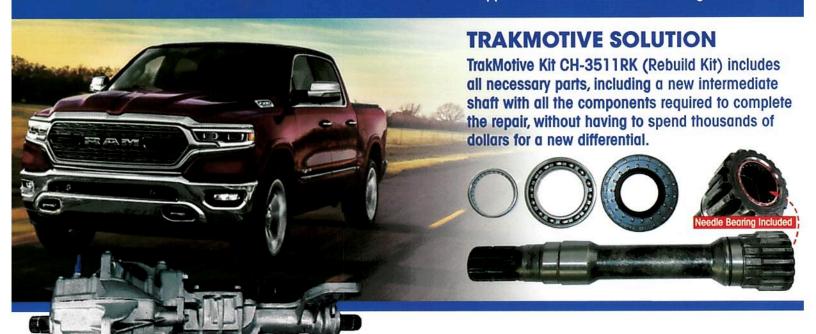
Clunking (or) vibration noises when trying to apply 4WD. The dashboard light indicates the Shift Actuator is working but it will not engage in 4WD. Issue: The front differential RHS (right hand side) Intermediate Shaft to CV inboard joint splines are stripped which also causes a bearing failure.

The original connecting CV Shaft could also be defective if the intermediate shaft is damaged and should be replaced.

We strongly Recommend Replacing the CV Shaft with a new TrakMotive CH-8256, CH-8256HDX or CH-8256XTT when completing the job.
